BUTTE-SILVER BOW COUNTY

Traffic Safety Improvement Plan

August, 1990

CLETE DAILY AND ASSOCIATES
TRAFFIC & TRANSPORTATION ENGINEERS
524 W. Lawrence • P.O. Box 223
Helena, Montana 59624

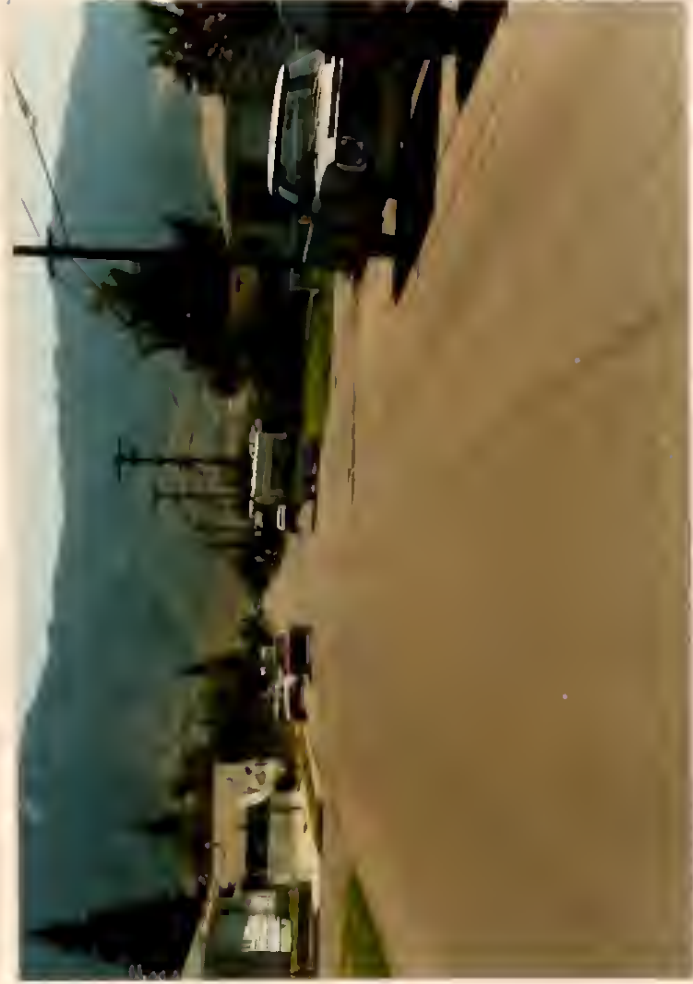
Site No. 4: Marcia and Wilson. West leg of the intersection of Marcia and Wilson looking east.

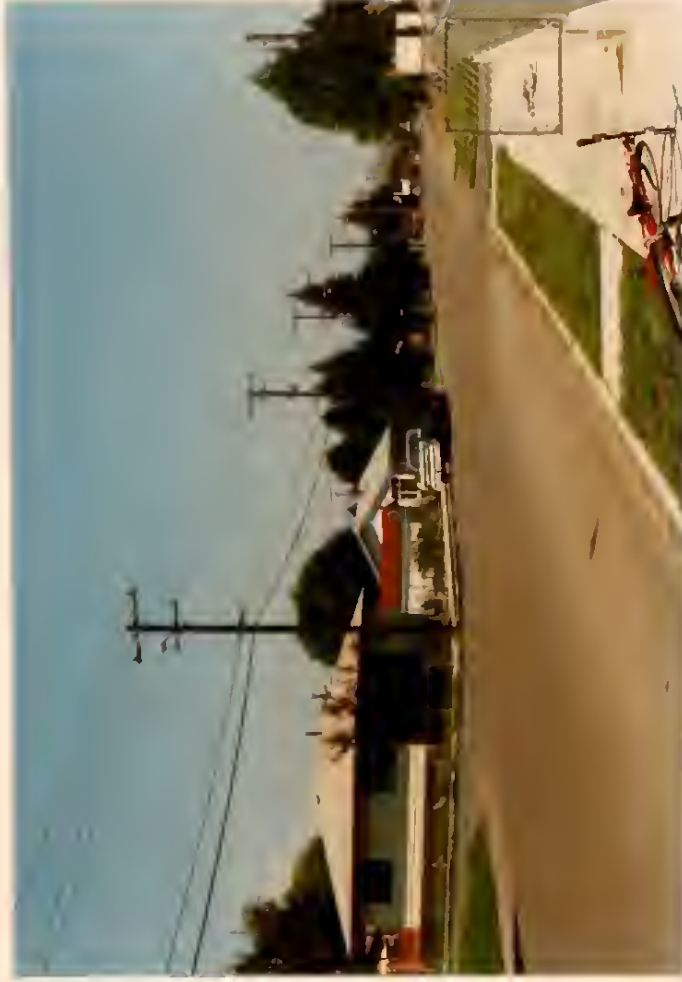
Site No. 4: Marcia and Wilson. East leg of the intersection of Marcia and Wilson looking west.

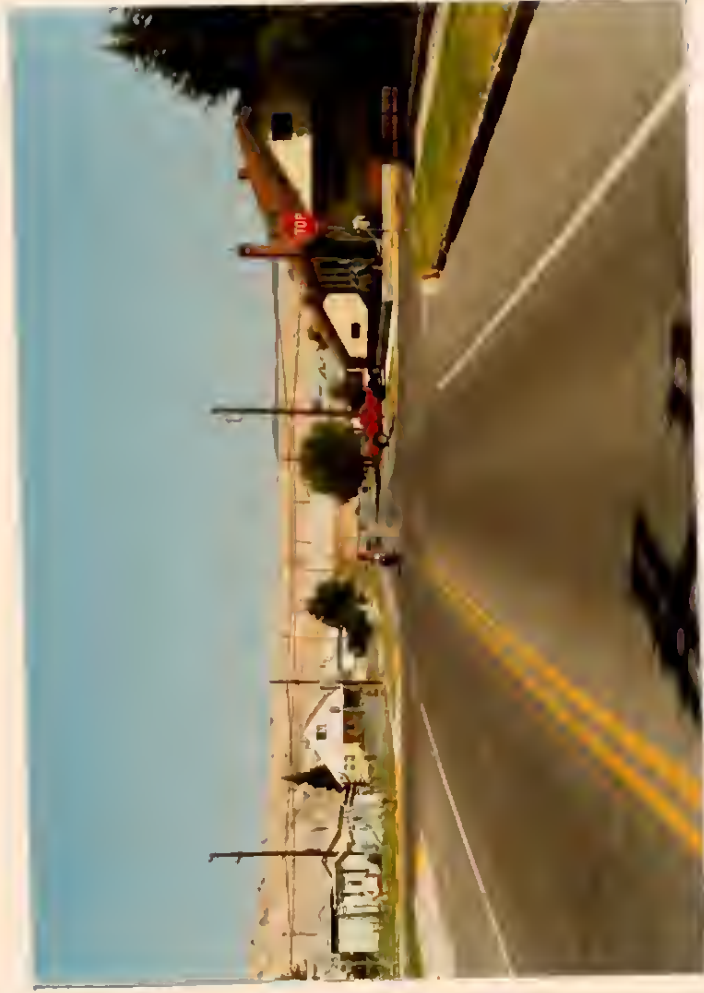
Site No. 5: Texas and Grand. South leg of the intersection of Texas and Grand looking north.

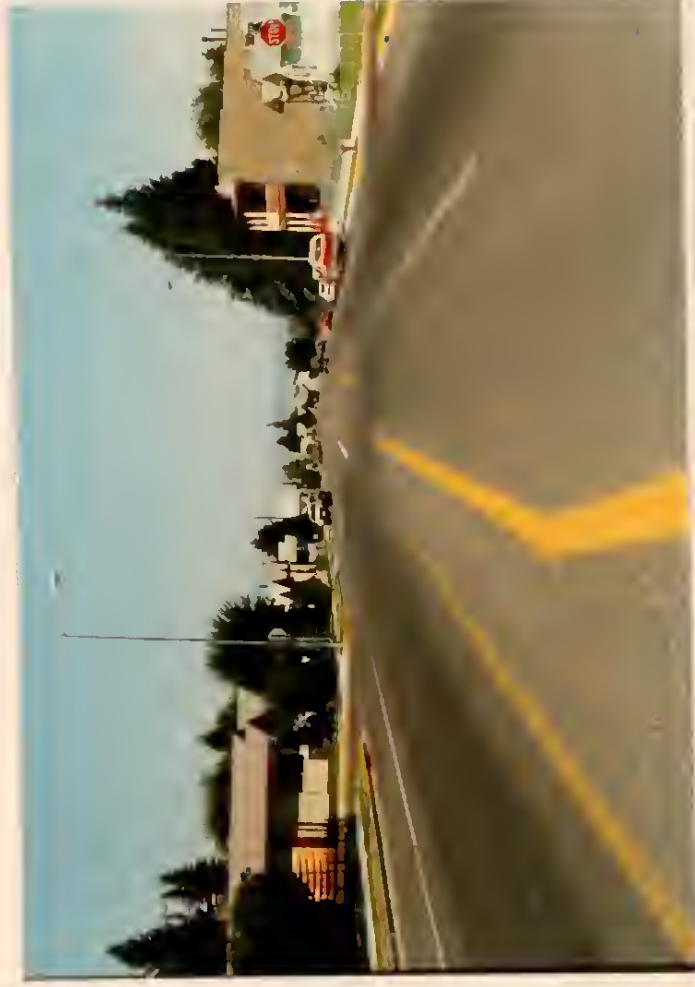
Site No. 5: Texas and Grand. East leg of the intersection of Texas and Grand looking west.

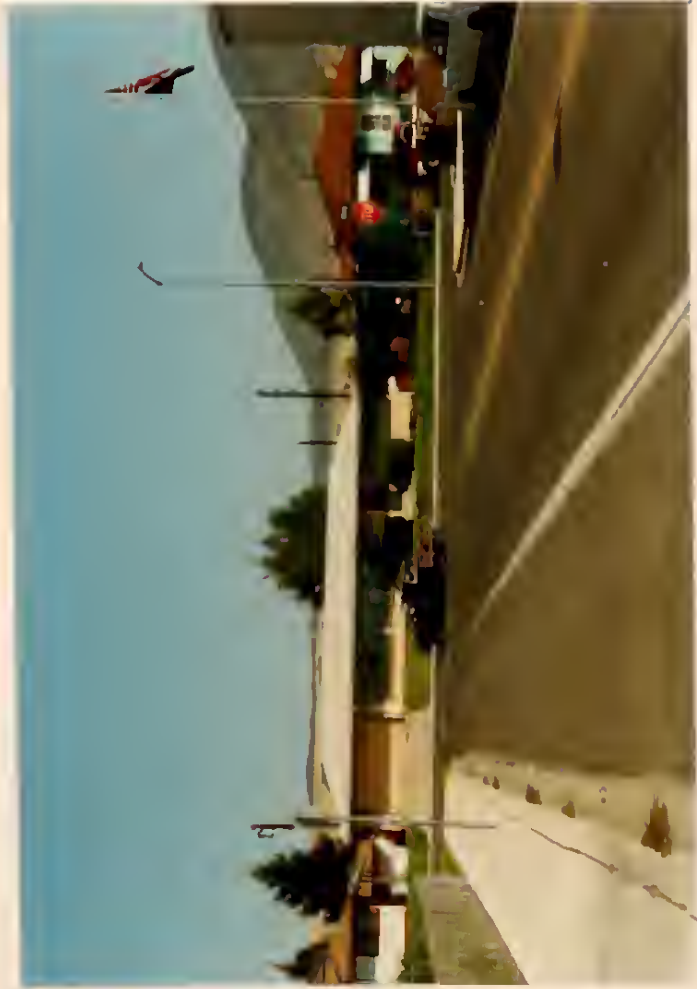
Site No. 6: Farragut and Grand. South leg of the intersection of Farragut and Grand looking north.

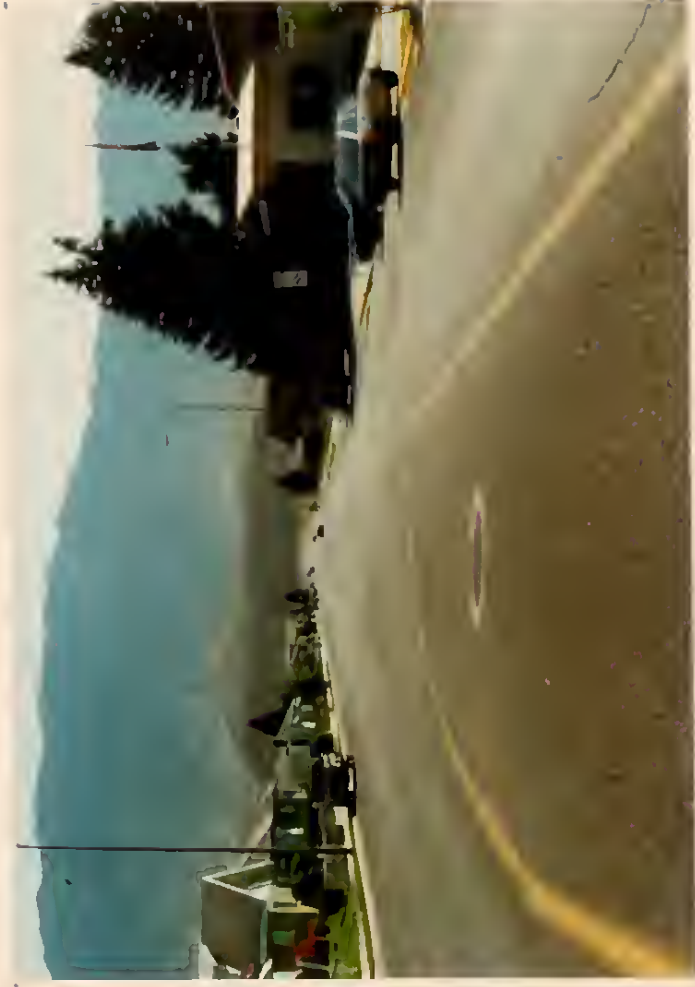
Site No. 6: Farragut and Grand. West leg of the intersection of Farragut and Grand looking east.

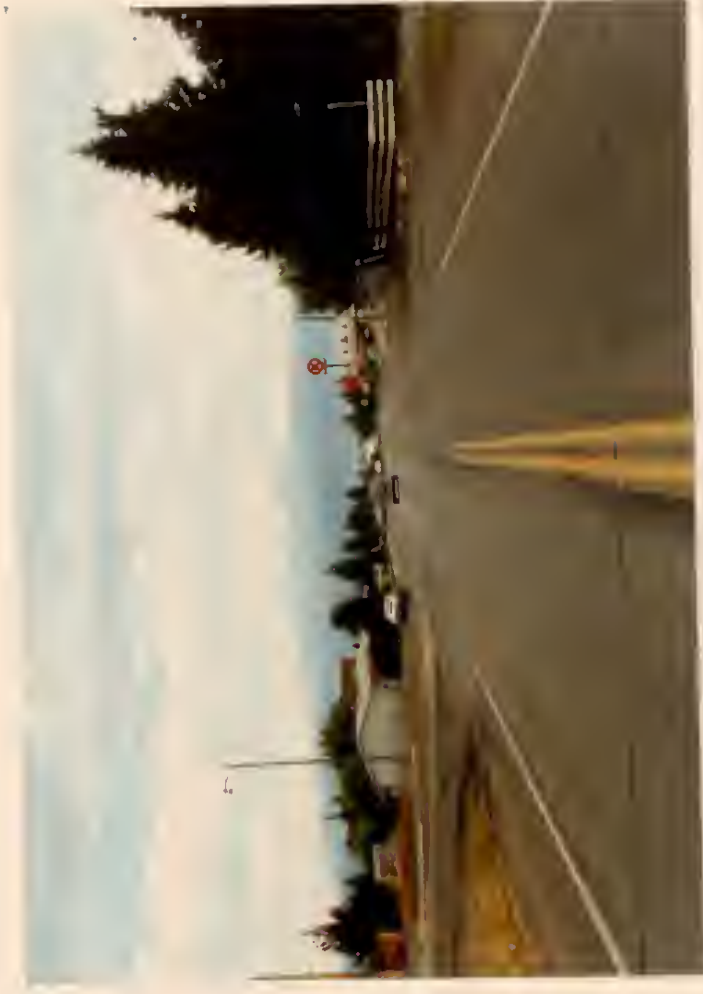
Site No. 8: Continental Drive and St. Anns. North leg of the intersection of Continental Drive and St. Anns looking south.

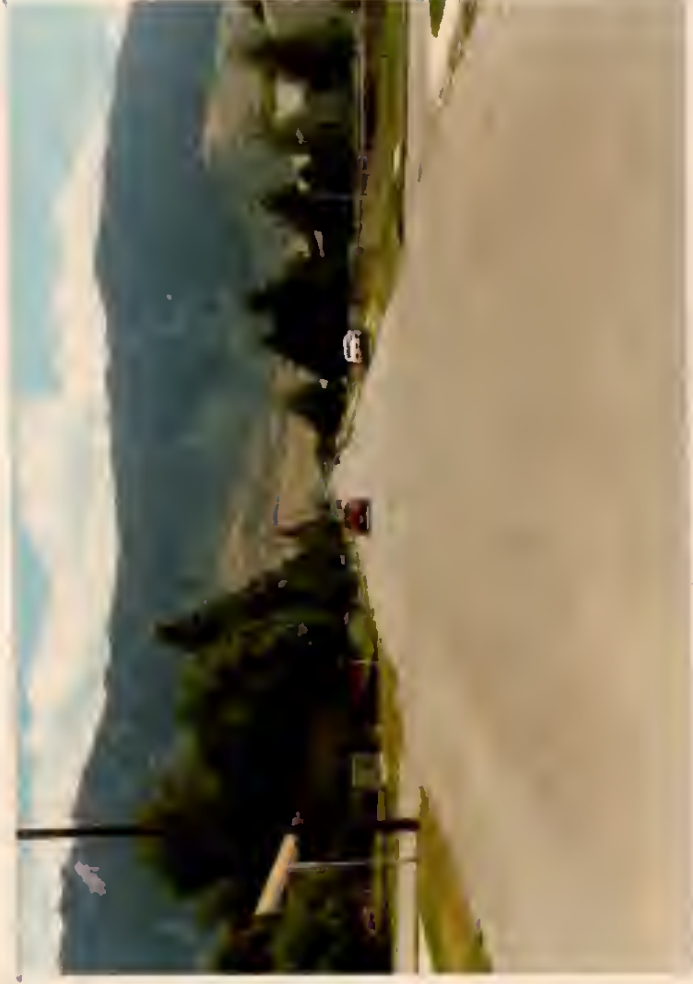
Site No. 9: Thomas and Moulton. West leg of the intersection of Thomas and Moulton looking east.

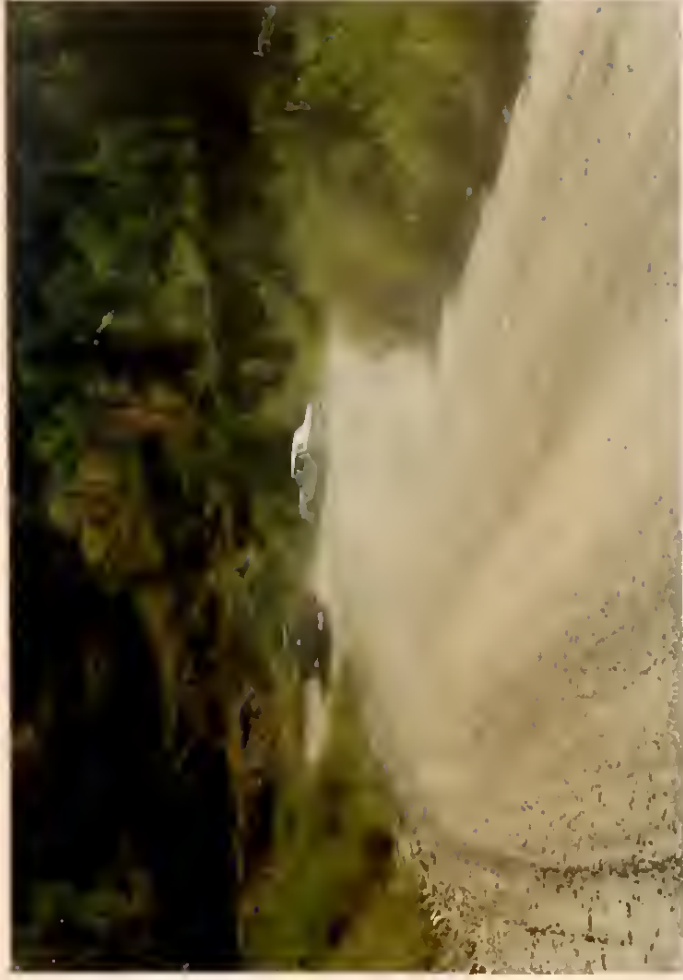
Site No. 10: Roosevelt Drive — curve. Southwest approach of curve on Roosevelt Drive looking northeast.

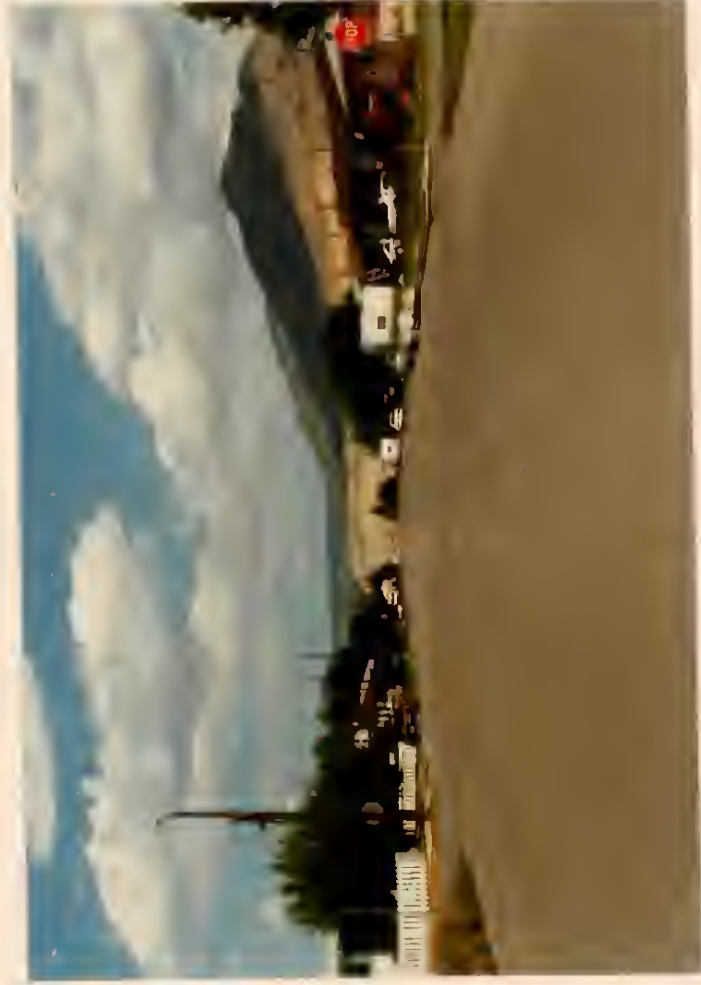
Site No. 11: Yale and Hancock. South leg of the intersection of Yale and Hancock looking north.

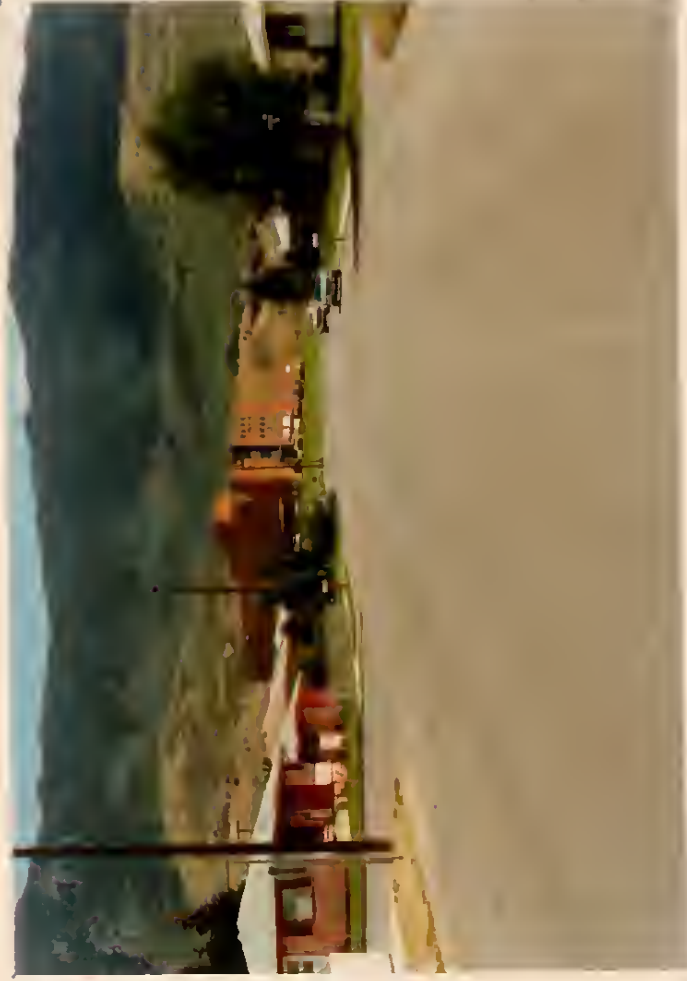
Site No. 11: Yale and Hancock. West leg of the intersection of Yale and Hancock looking east.

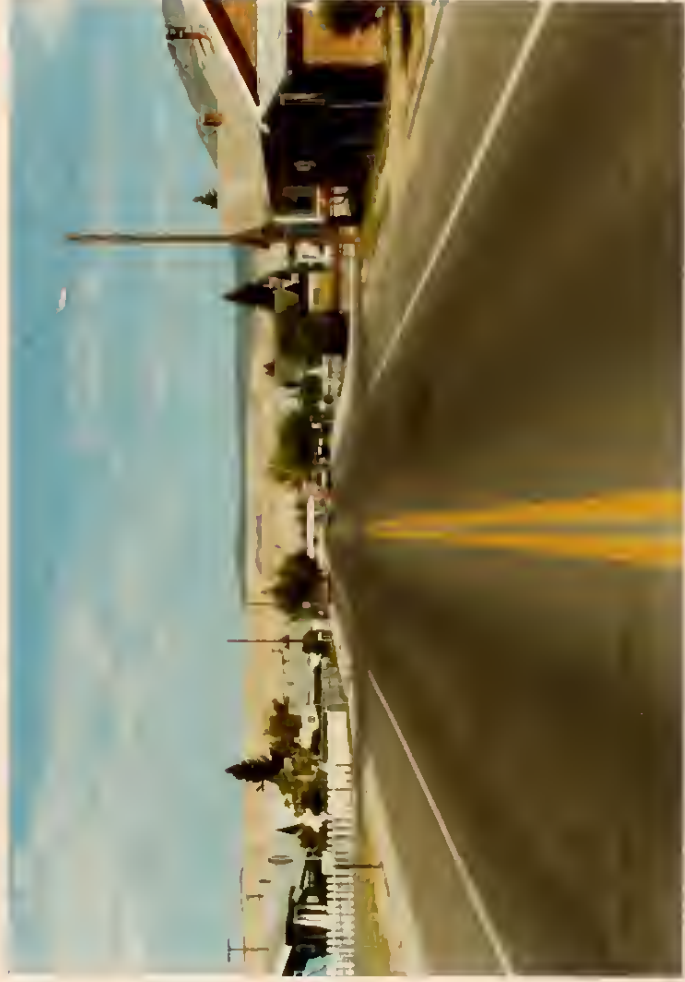
Site No. 12: Farragut and George. South leg of the intersection of Farragut and George looking north.

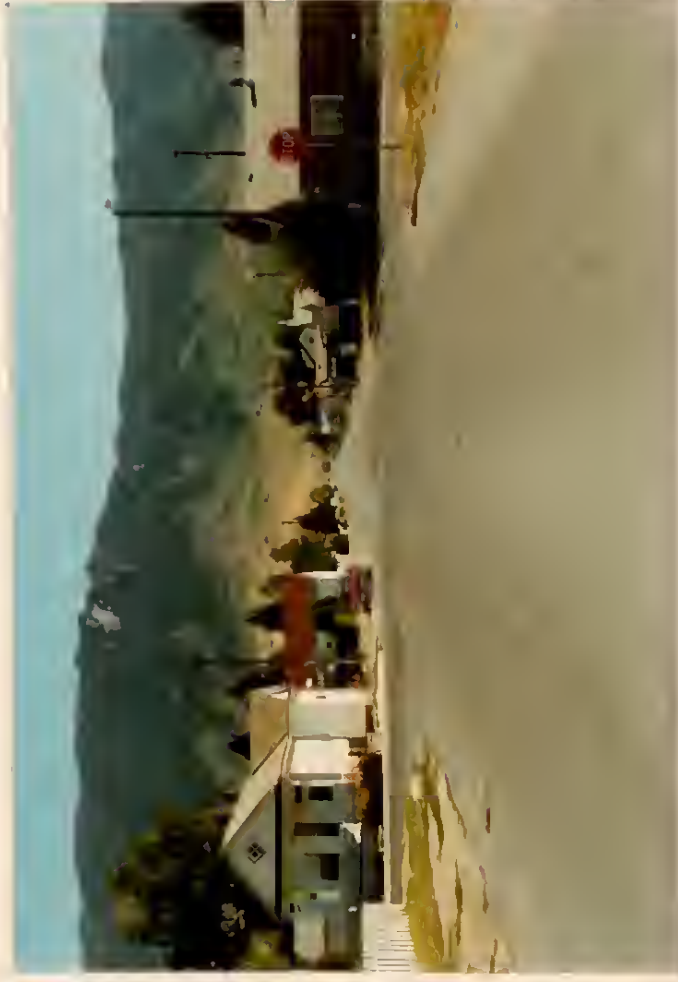
Site No. 12: Farragut and George. West leg of the intersection of Farragut and George looking east.

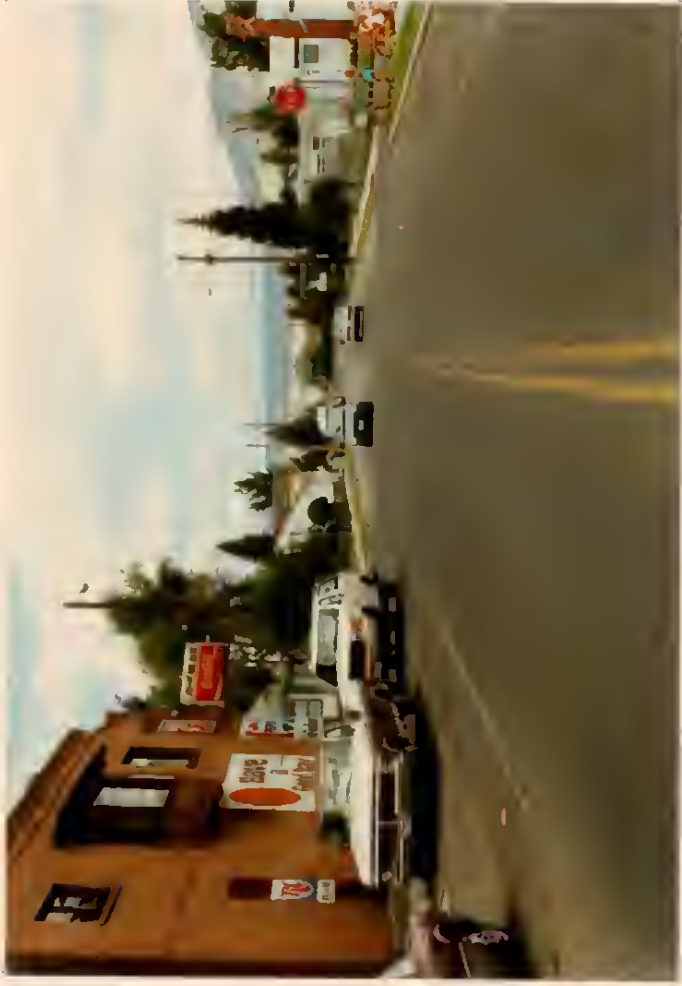
Site. No. 13: **Floral and Sheridan.** South leg of the intersection of Sheridan and Floral looking north.

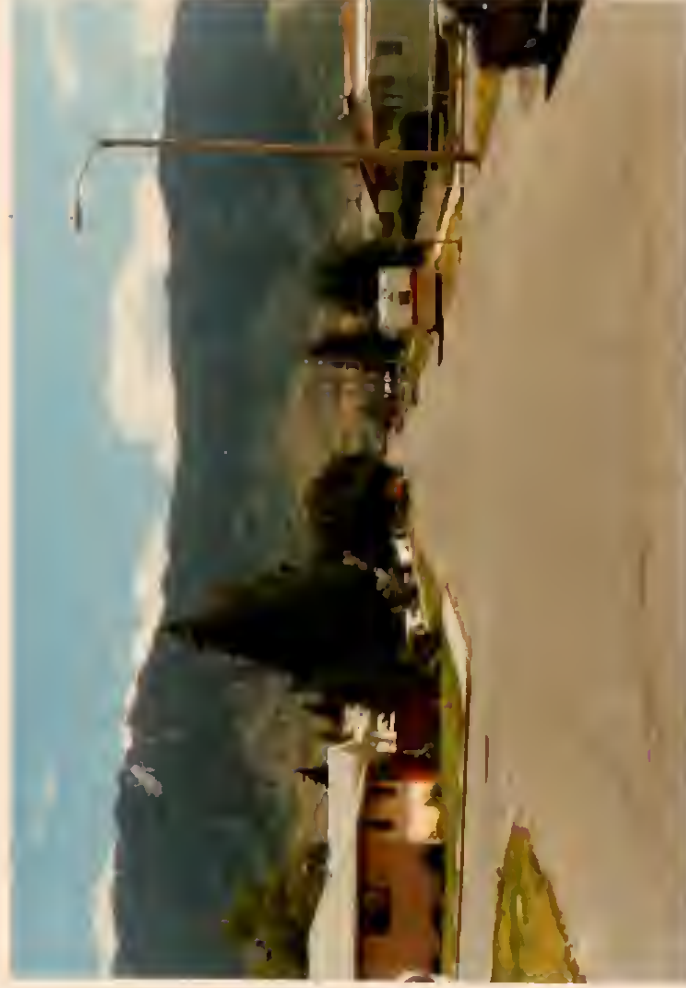
Site No. 14: Thomas and Kossuth. West leg of the intersection of Thomas and Kossuth looking east.

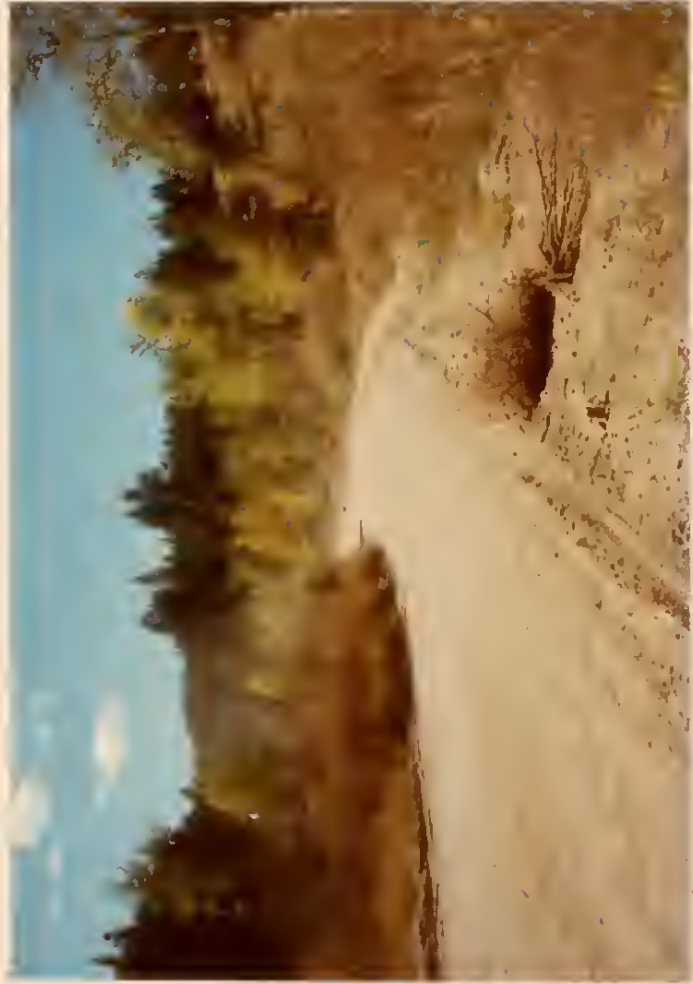
Site No. 15: Roosevelt Drive — Hill. East approach of Hill on Roosevelt Drive looking west.

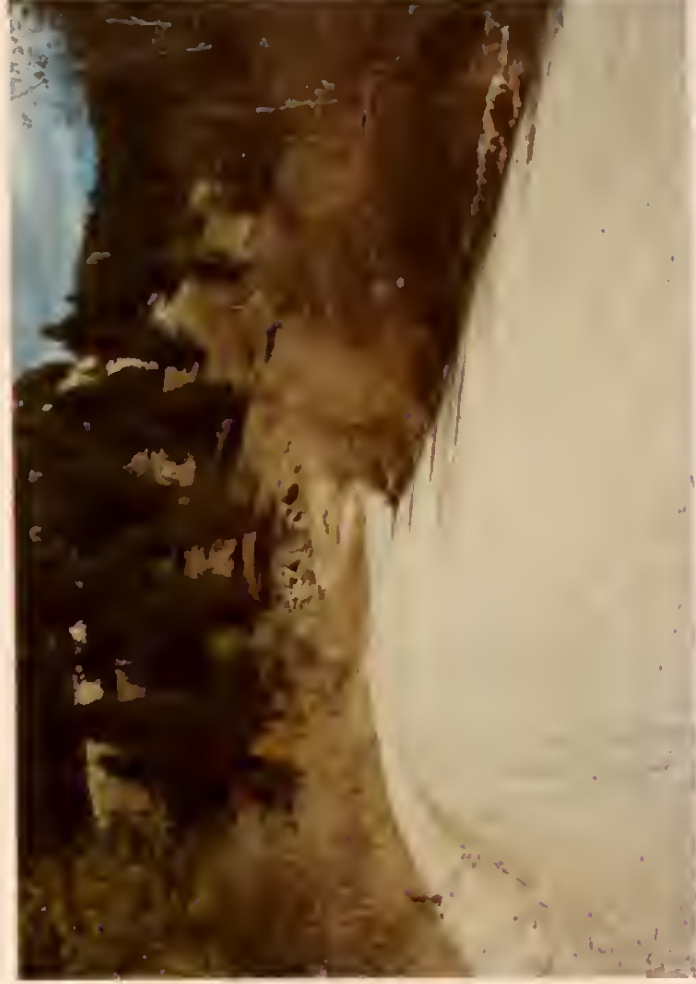
Site No. 15: Roosevelt Drive — Hill. West approach of Hill on Roosevelt Drive looking east.
